BUREAU OF SHIPS GROUP TECHNICAL INSPECTION REPORT.

OPERATION CROSSROADS.

U.S.S. LCT's 705, 816, 818, 874, 1013,

TEST BAKER [U] • (E)

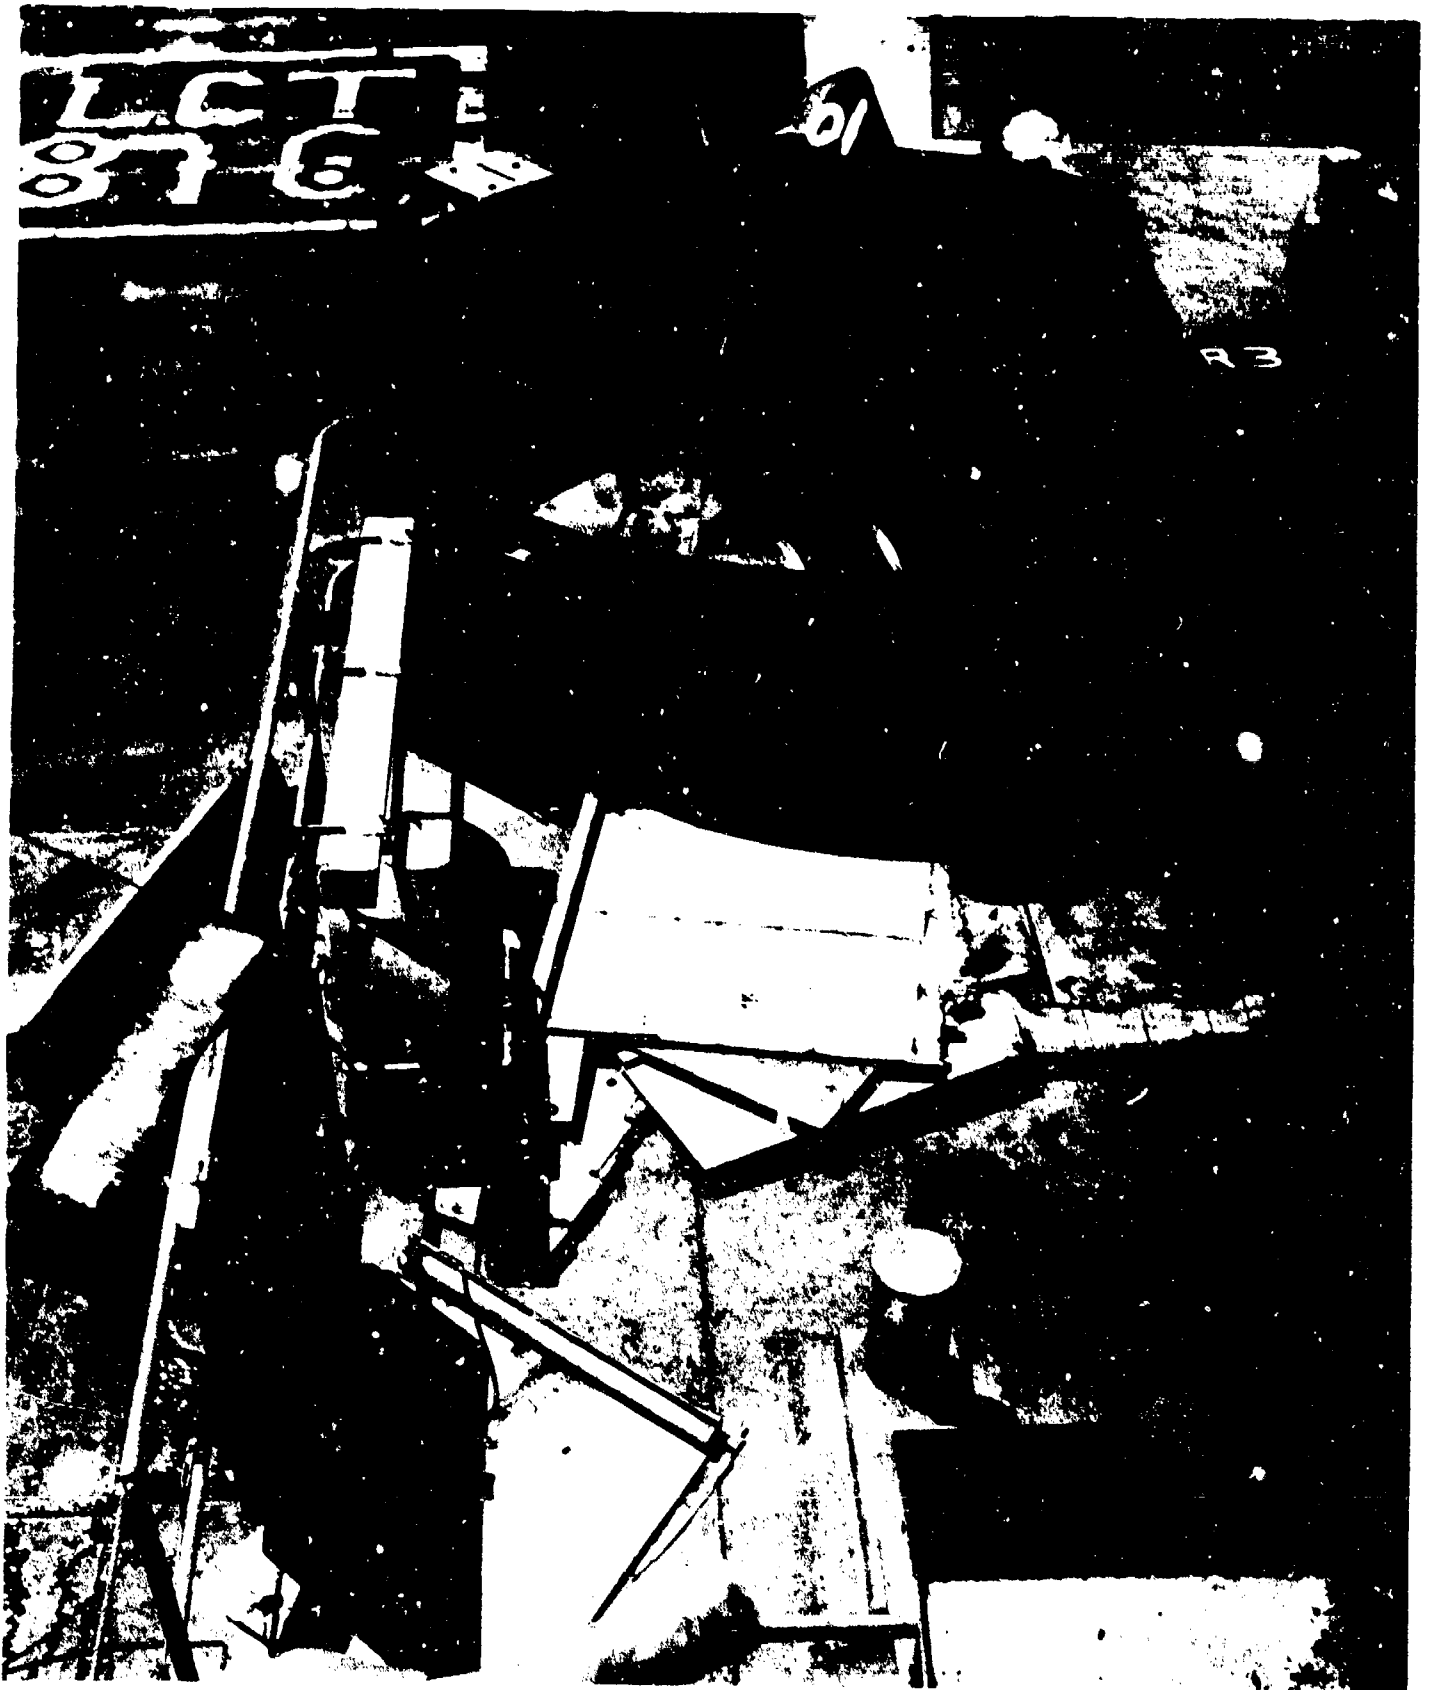
There is a general moderate dishing of the starboard superstructure. Handrails and the IFF antennae are bent. (Photos 4046-9, 10, 11, 12 pages 60, 61, 62, and 63). The port superstructure suffered some mild dishing. The stub of the wood mast broke off and a portion of it was found on the tank deck. (Photo 4045-2, page 64).

AB-CR-97-4046-10. Top of starboard deck house.

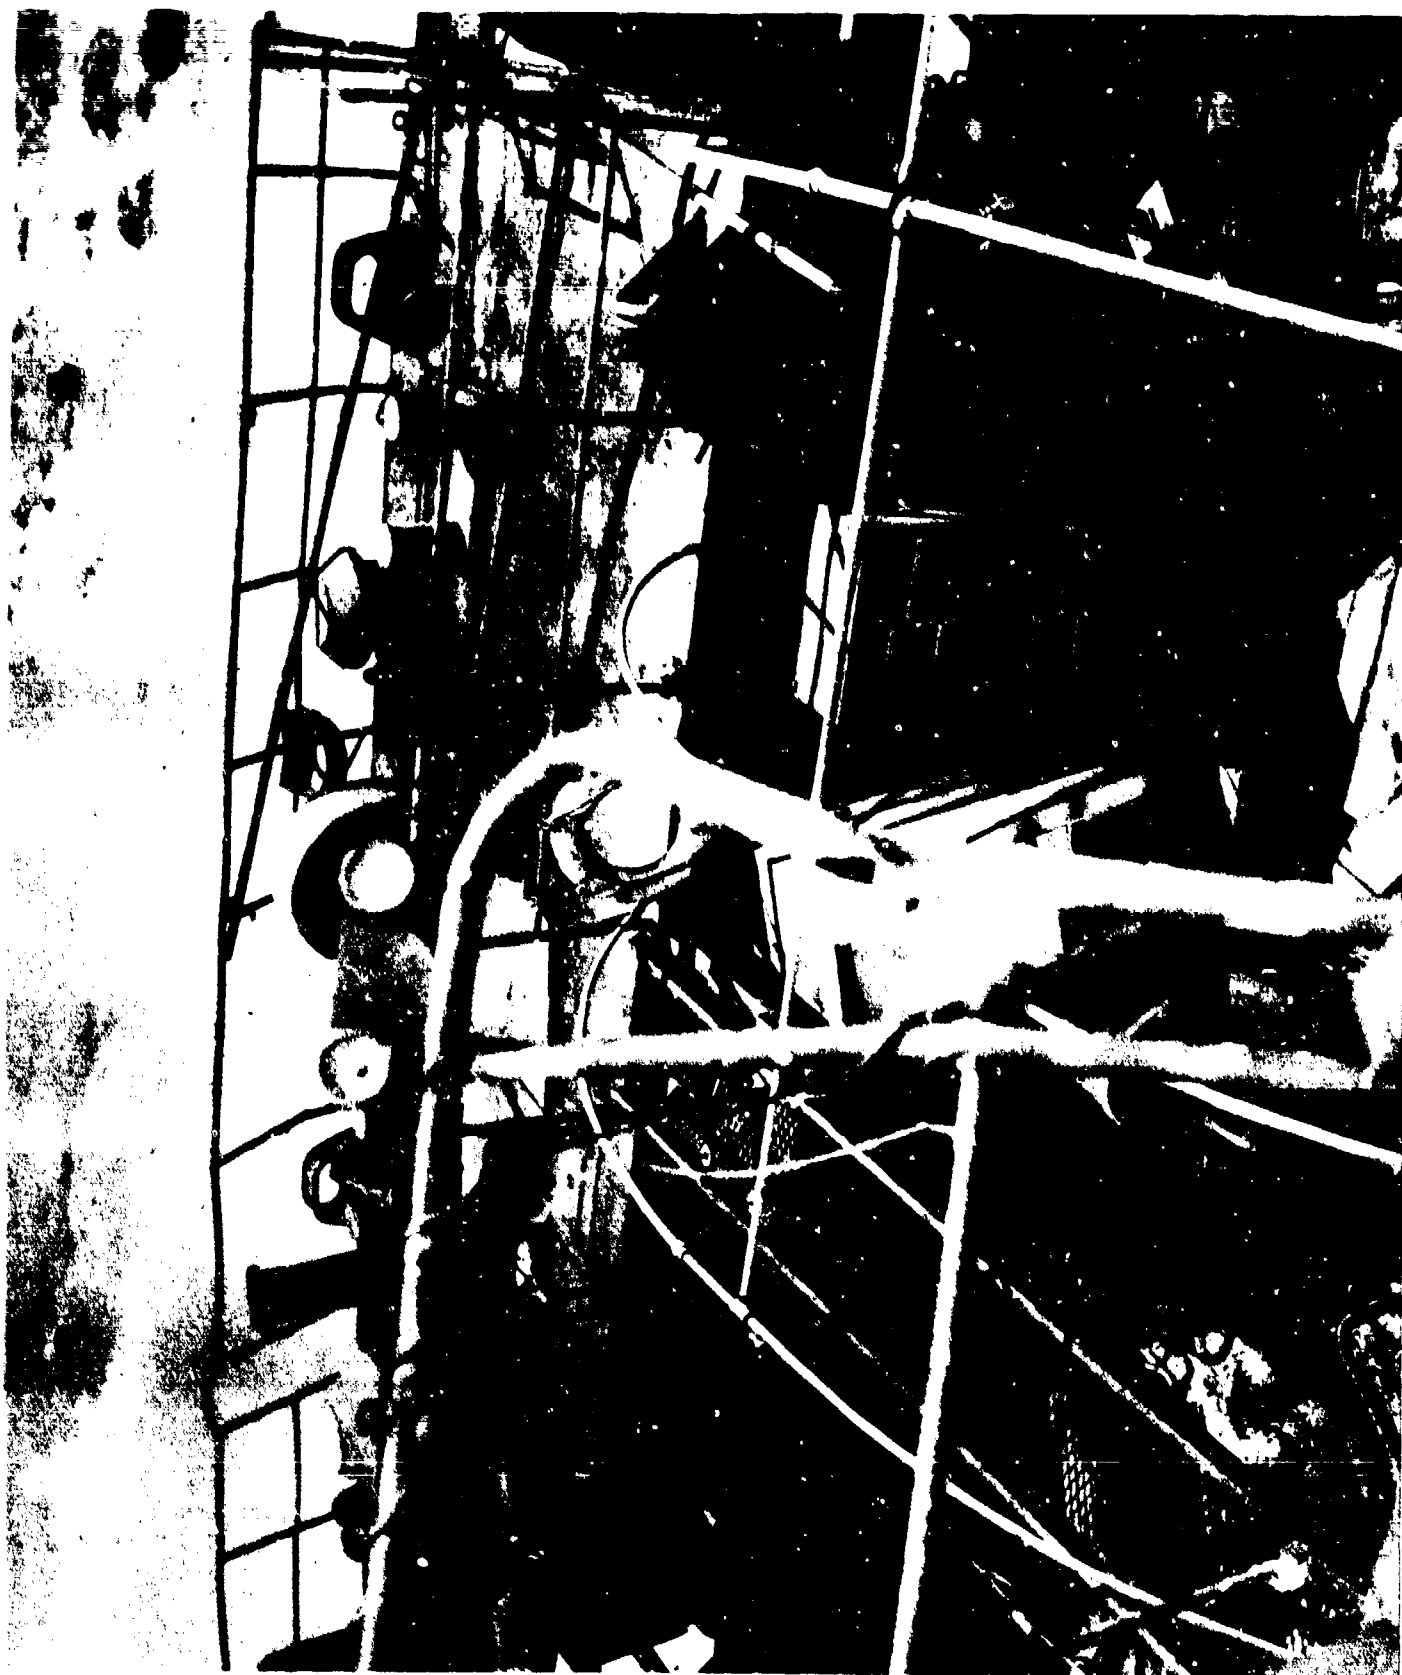
AB-CR-97-4046-12. Top of port deck house, after section.

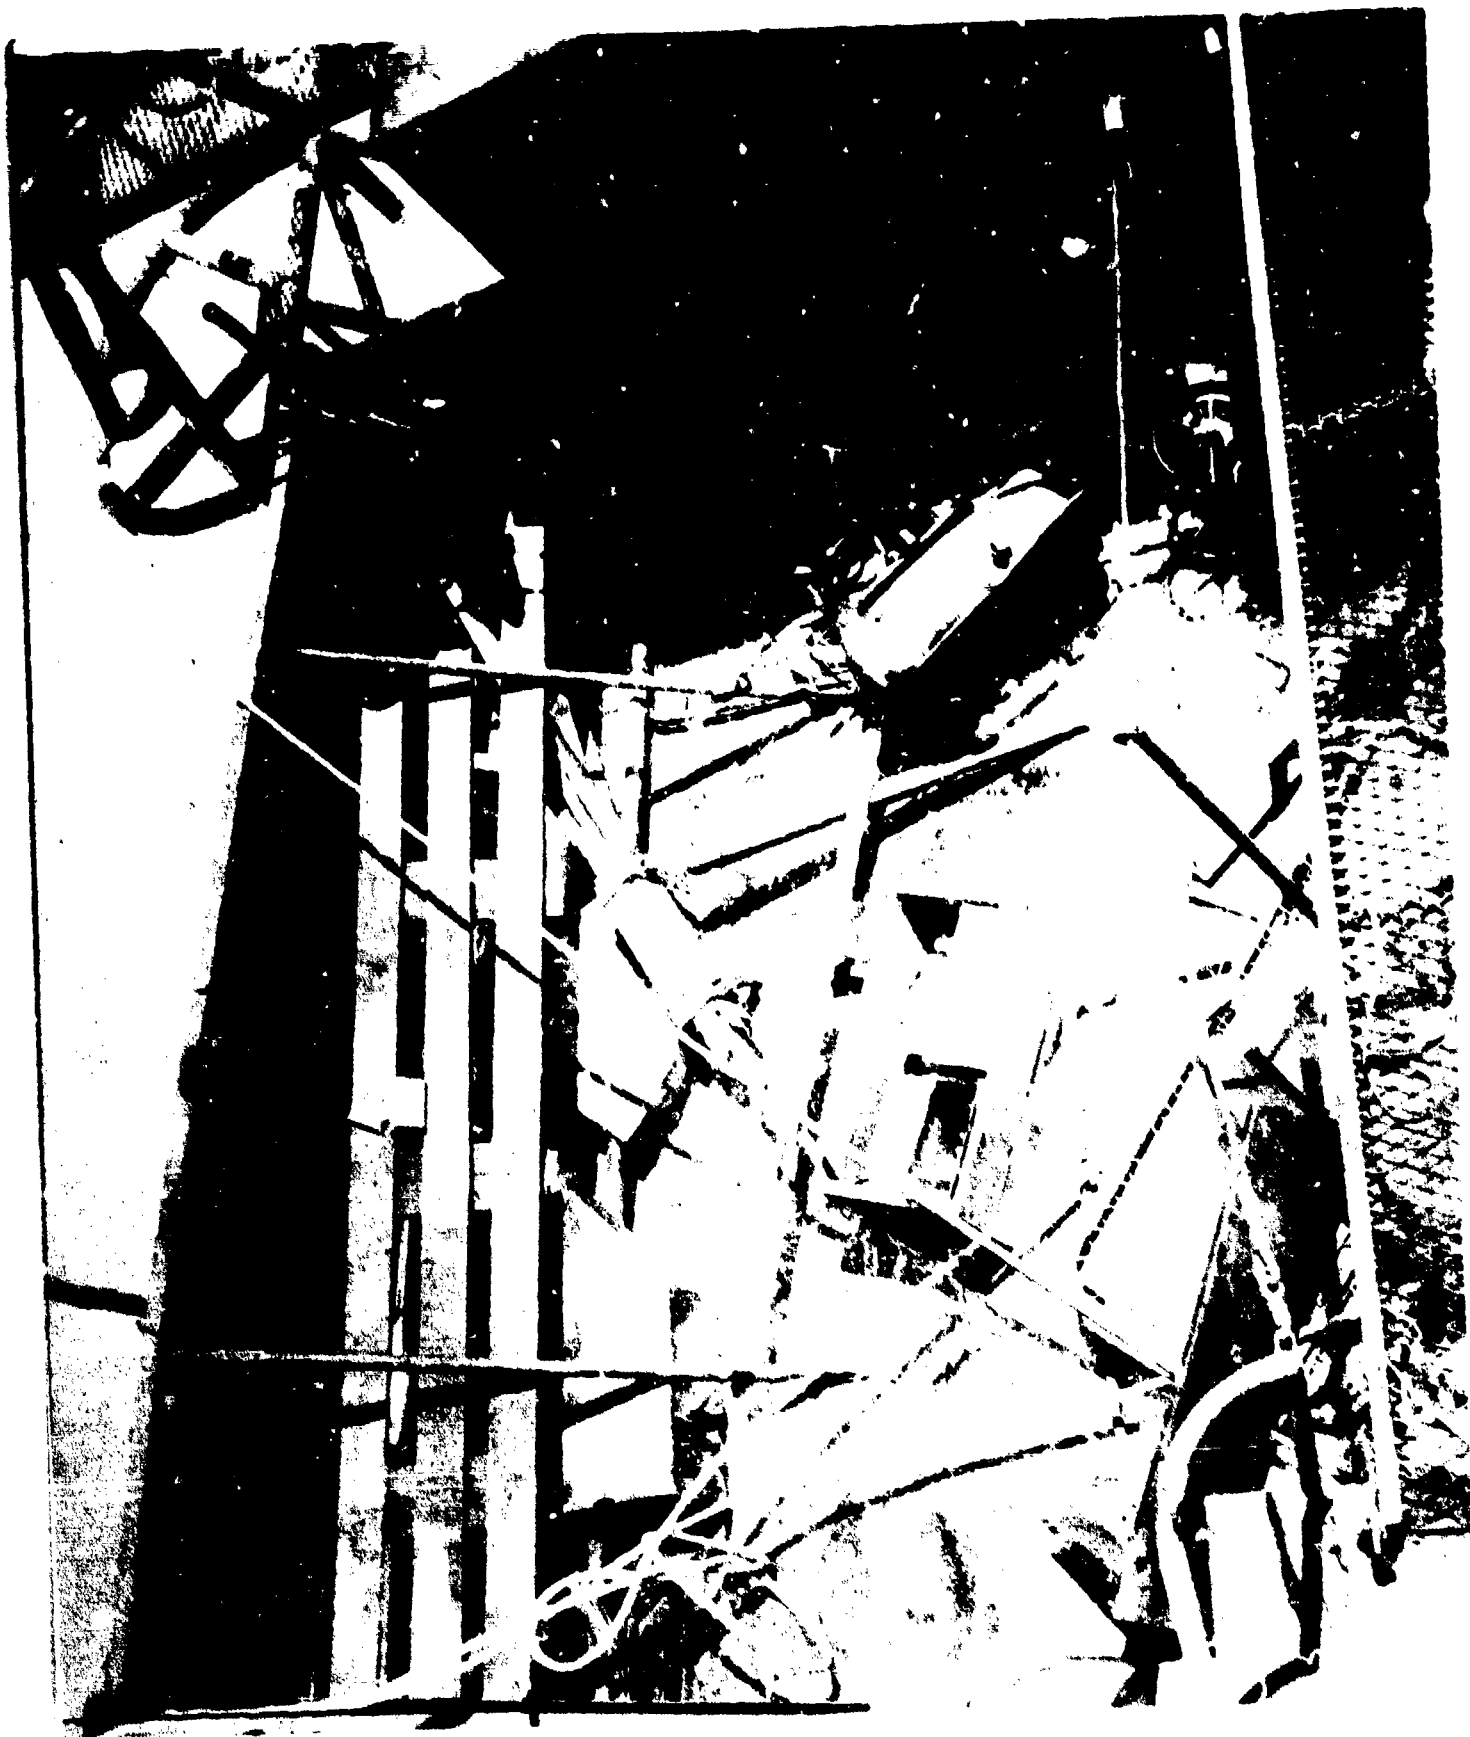
The port and starboard bulwarks are bowed to port about 12 inches. Loose equipment and fittings have been scattered on the tank deck. (Photos 4045-1, 2, 4, and 5, pages 65, 64, 66, and 67).

AB-CR-97-4045-2. After end of tank deck.

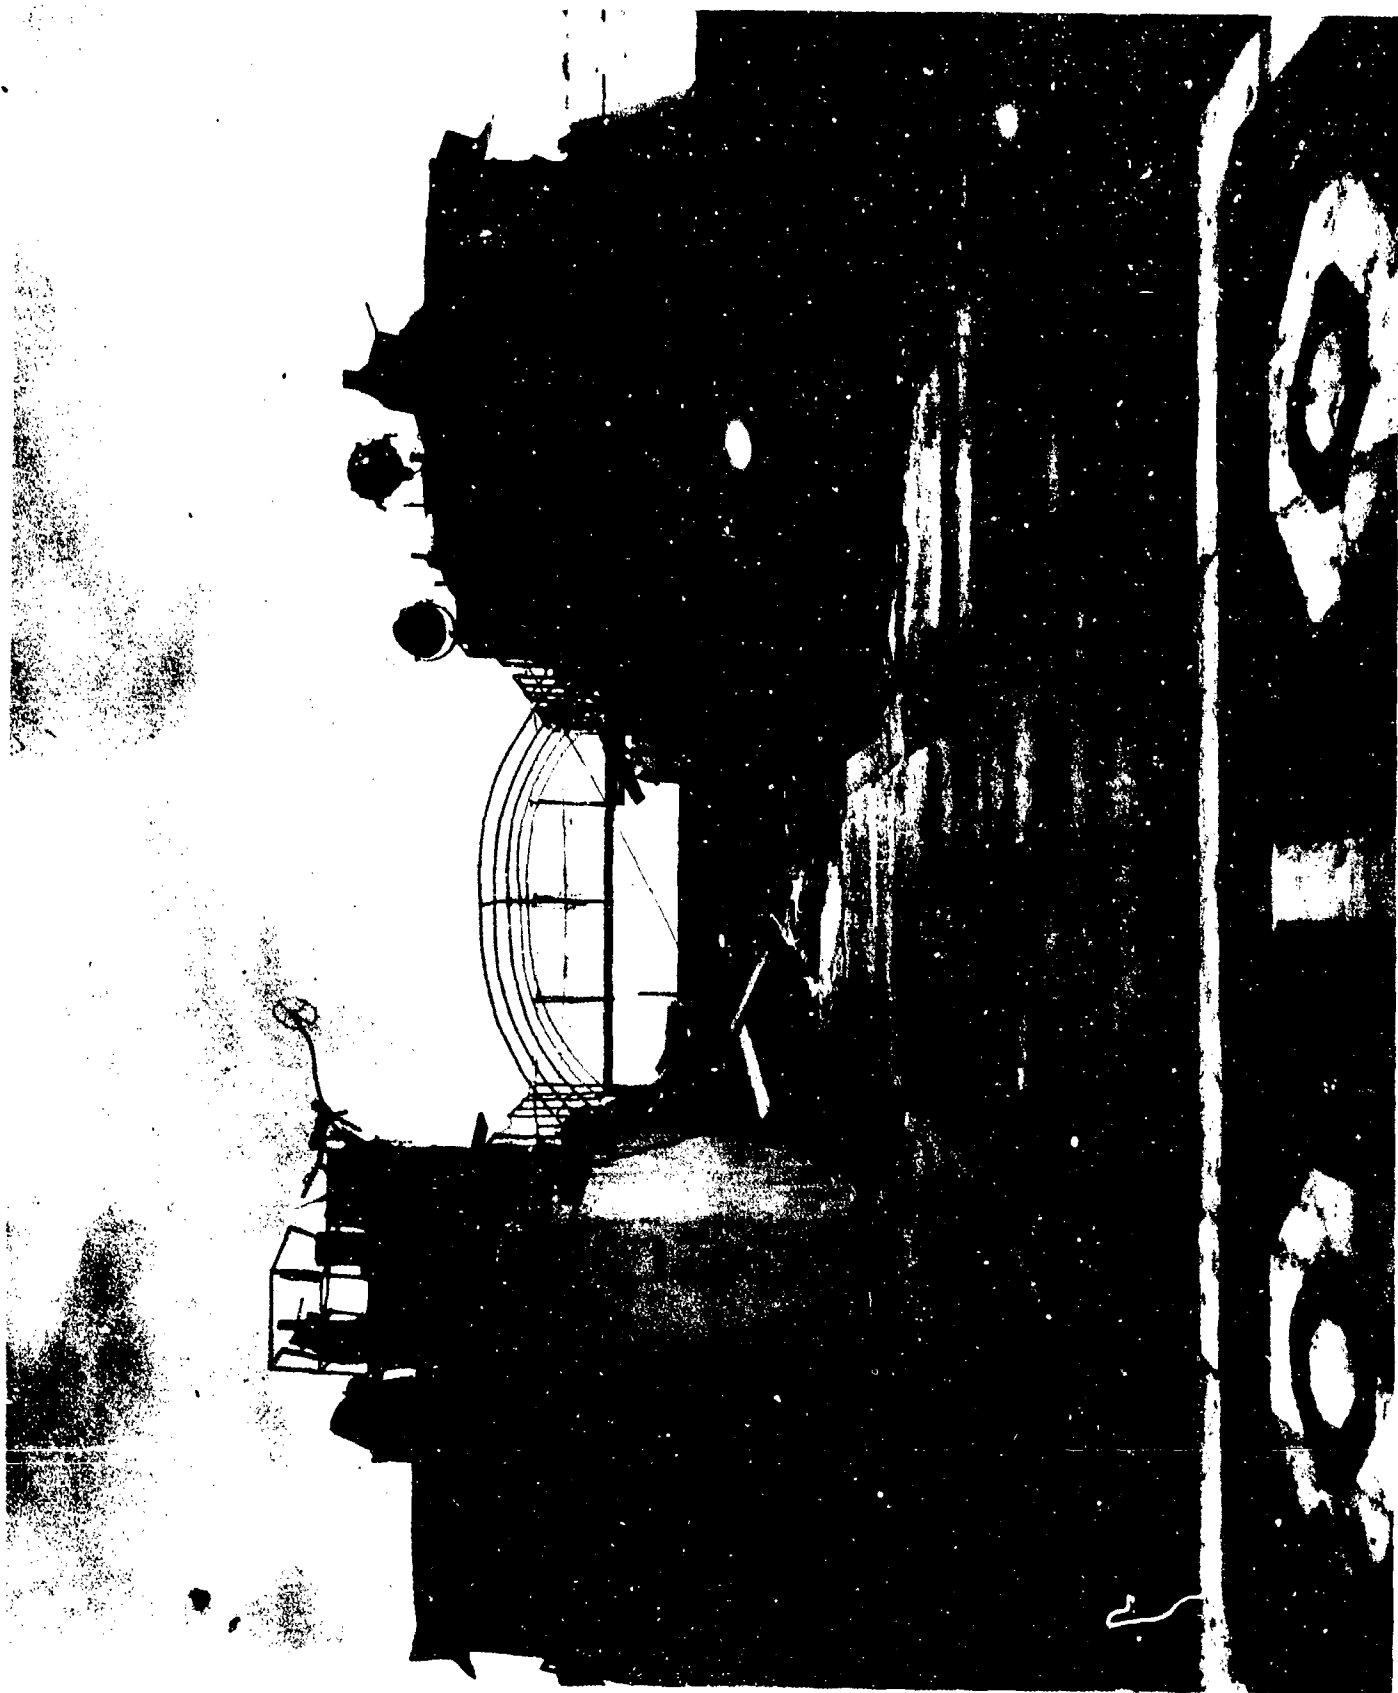
AB-CR-97-4045-5. Looking aft on tank deck.

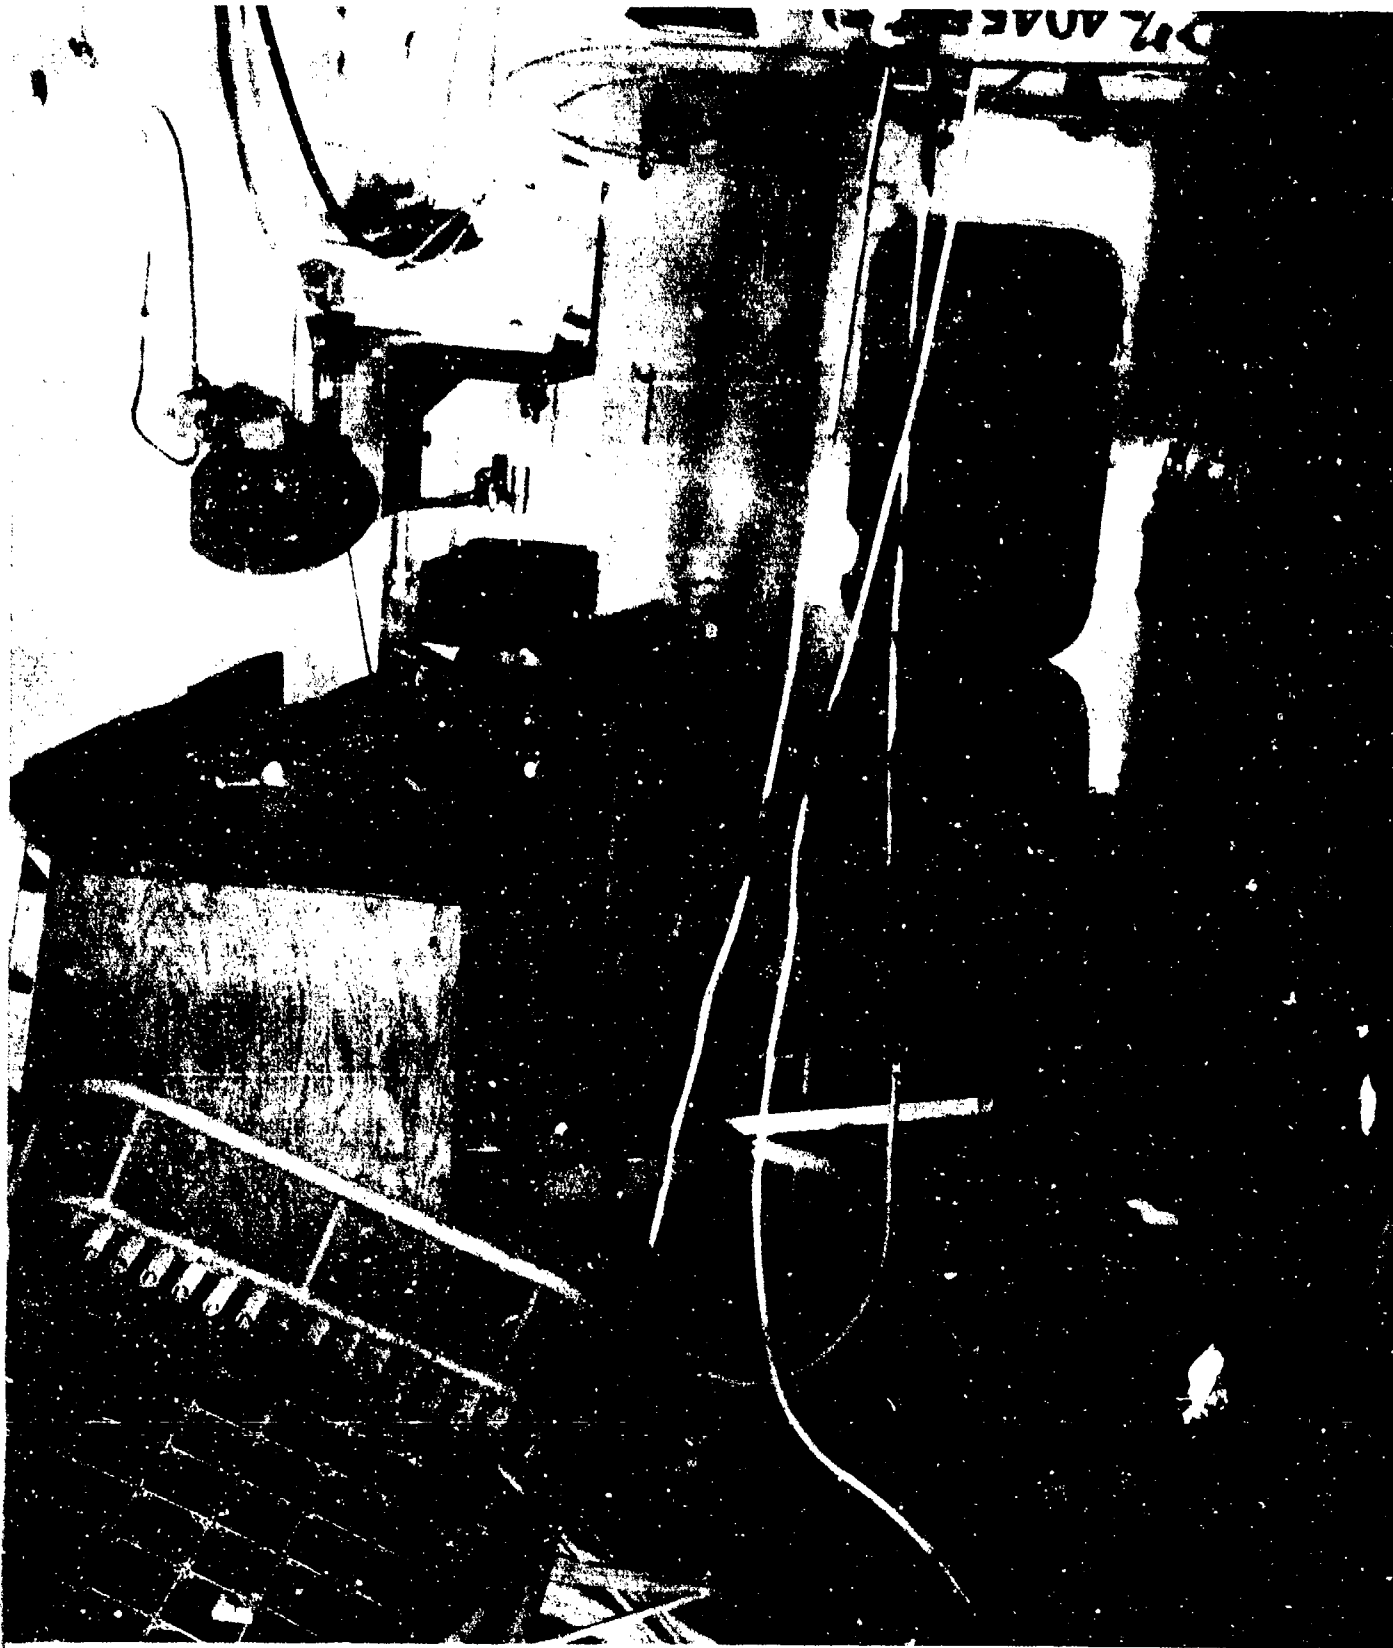
Loose equipment and fittings in interior spaces have been scattered (Photo 4045-3, page 68).

AB-CR-97-4045-3. Disarranged equipment in starboard crew's quarters.
